Property Location: 12345 Main Street, Client City, Client State

ASBESTOS SURVEY REPORT

11/30/2015

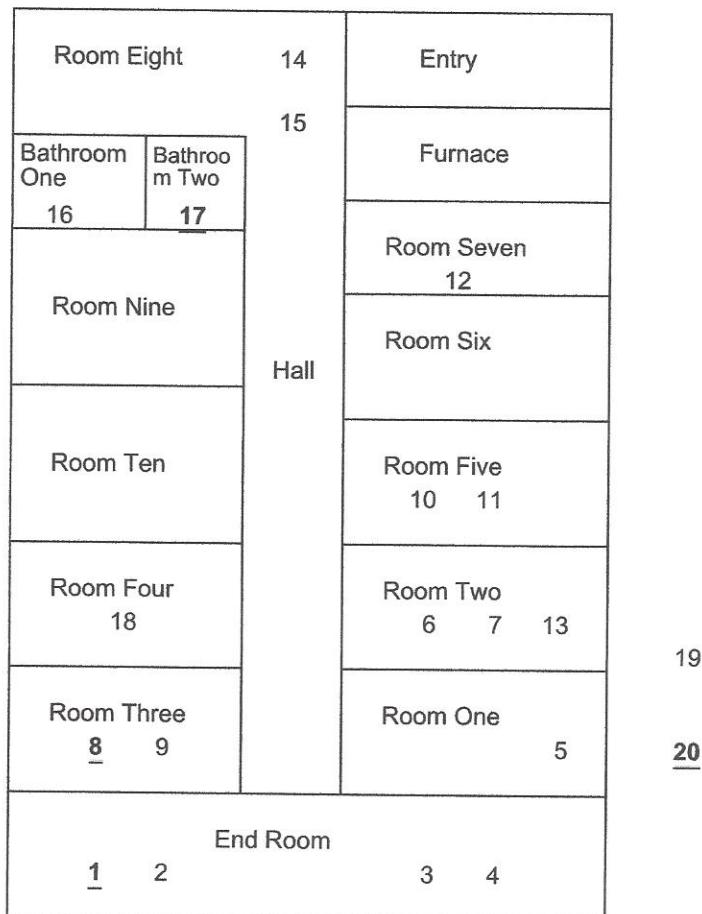
FLOOR PLAN AND SAMPLING SCHEME - 1

Three ACMs were found on the client property during the inspection: (1) Green tile with 3% Chrysotile found in the entire floor under the carpets, (2) Black mastic with 3% Chrysotile found in the entire floor under the carpets, and (3) Gray brittle material with paint with 2% Chrysotile found on the windows.

Note: (1) Positive samples in bold face and underlined, (2) Map not exact, not in scale
